## Case Study: Protecting Tree Roots with FRP Grating

**Location:** Urban walkway, New Zealand **Product:** FRP Micro Mesh Grating **Industry:** Public Infrastructure

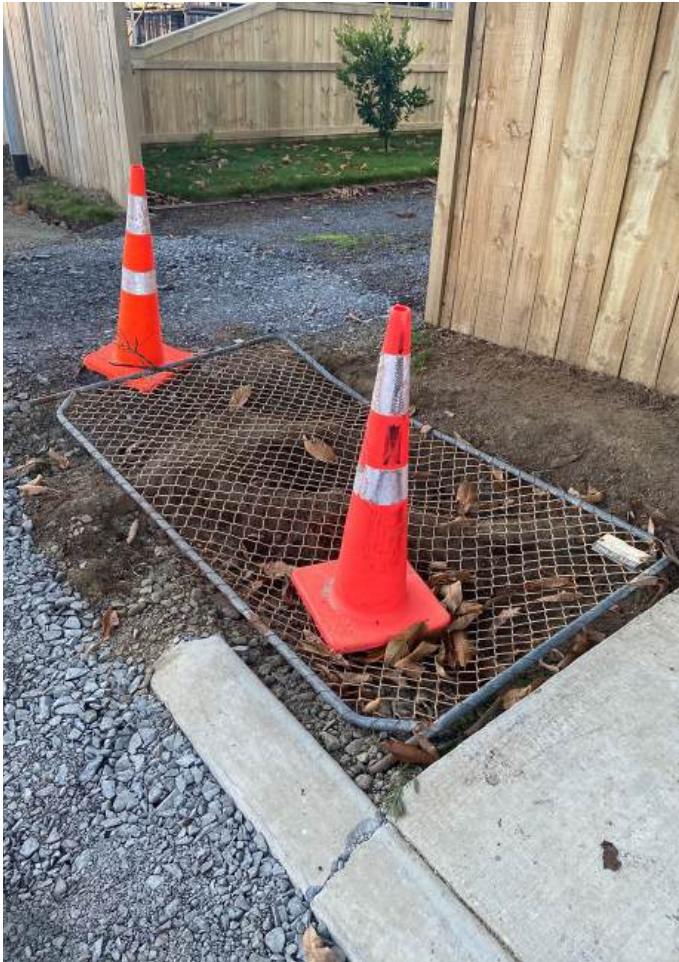
Exposed tree roots created safety and maintenance concerns along the walkway.

- The client required a solution to protect exposed tree roots from damage caused by frequent pedestrian traffic.
- The solution needed to maintain the walkway's appearance, comfort, and functionality, without compromising usability or aesthetics.
